Changes in the Building Fabric

Source: *The First Mormon Temple: Design, Construction, and Historic Context of the Kirtland Temple*

Chapter 8

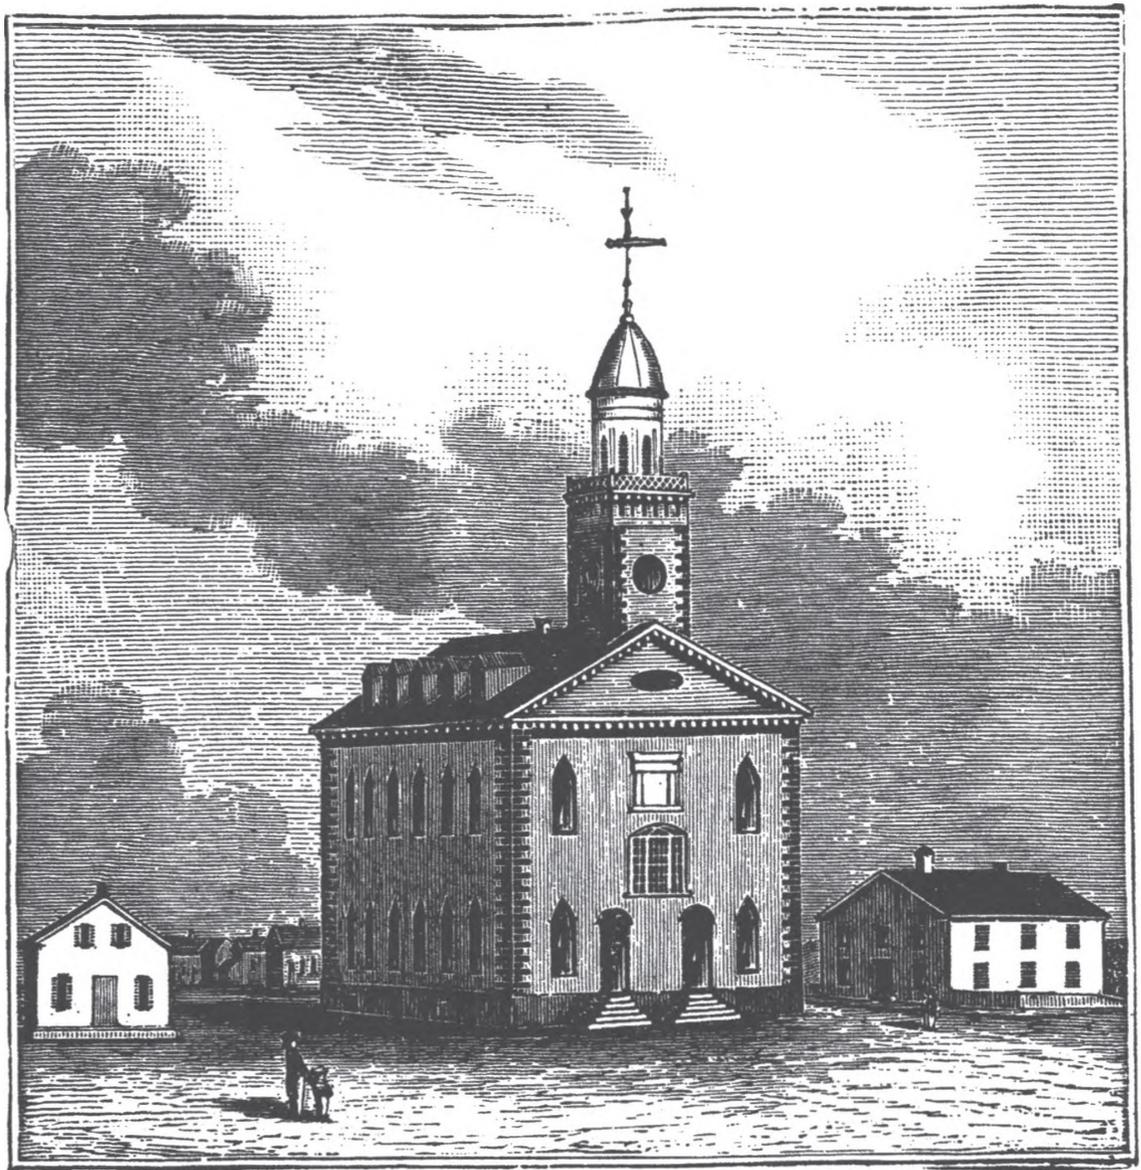
8-2. Woodcut prepared from an 1846 sketch by Henry Howe. From Howe, *Historical Collections of Ohio*. The chimney, which served the temple's four stoves, is visible just beyond the tower.

This visual change is even more pronounced due to the changes made to the tower between 1941 and 1950.²⁴ The flushboard siding originally covering the tower and gable ends (fig. 8-2) was replaced with the more common overlapping clapboard siding (fig. 8-7). Not as weathertight, flushboarding was generally used to imitate the smooth surface of masonry construction. Flushboarding was sometimes used on the facade of public buildings, as the absence of horizontal shadow lines gave what was considered to be a more refined or monumental look. With the smooth stucco surface beneath, flushboarding in the temple's gables and tower visually linked the masonry walls and wooden gables, giving a more unified appearance to the structure. The corners of the tower have wooden blocks imitating the stone quoins of the walls below, and originally these, along with other decorative elements, were painted a darker color imitating the stone ornament below (figs. 8-2, 8-3). This paint scheme strongly tied together the lower walls and tower and emphasized the Georgian ornament of the walls below.

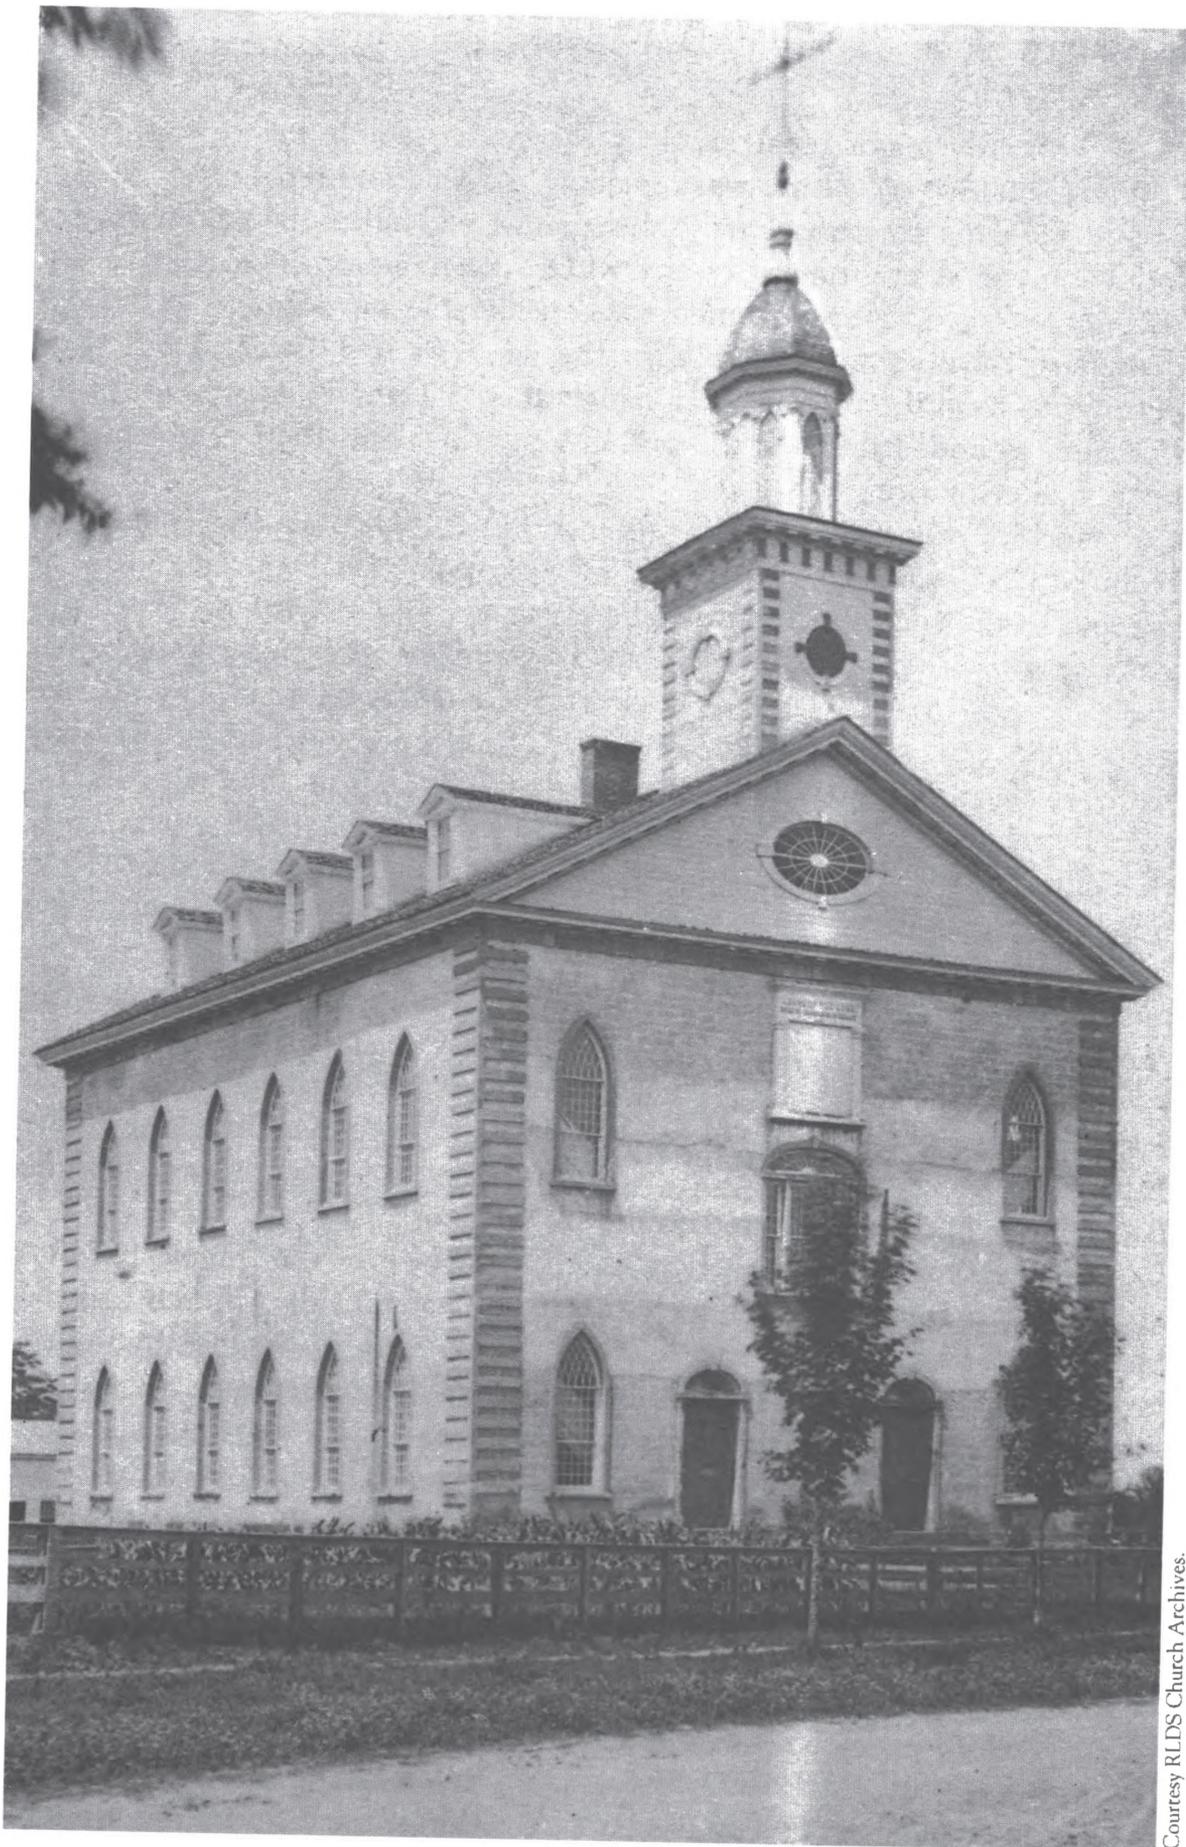
8-3. Kirtland Temple from the southeast. Photographed by "Faze the Rambling Artist," ca. 1875. The wooden quoins on the tower were painted to match the stone quoins below. The belfry, not yet fitted with a bell, has solid panels in the openings. Painted joint lines are visible where the temple's walls are in shadow, and faint horizontal markings show where one day's plastering ended and another commenced.

When the bell was installed, the panels that had closed up the belfry arches were replaced with horizontal louvers that let the sound of the ringing bell project to the surrounding countryside (figs. 8-3, 8-4). Unfortunately, these louvers also permitted rain and snow to enter the belfry and collect on the bell deck, causing the timbers to rot. By 1904 the deterioration of the structure and the action of the heavy bell swinging to and fro caused the weather vane to rock in the wind.²⁰ Providentially, a bolt of lightning struck the tower on August 13, 1904, badly damaging the belfry and roof, although a bucket brigade saved the temple from fire (a fate which did not escape a barn immediately adjacent to the temple). Since the temple was fully insured, the insurance money must have been what finally financed the needed repairs, which were undertaken in the fall of 1904.²¹

cement finish was left a natural gray color for about a decade before it was painted its current brilliant white. This new appearance of the temple reflects the clean, white look of the Modern Movement in architecture, which was in vogue in the 1960s. Unfortunately, this twentieth-century aesthetic is very different from the Georgian–Greek Revival look of the elements in their original, strongly projecting form (compare with fig. 8-3).

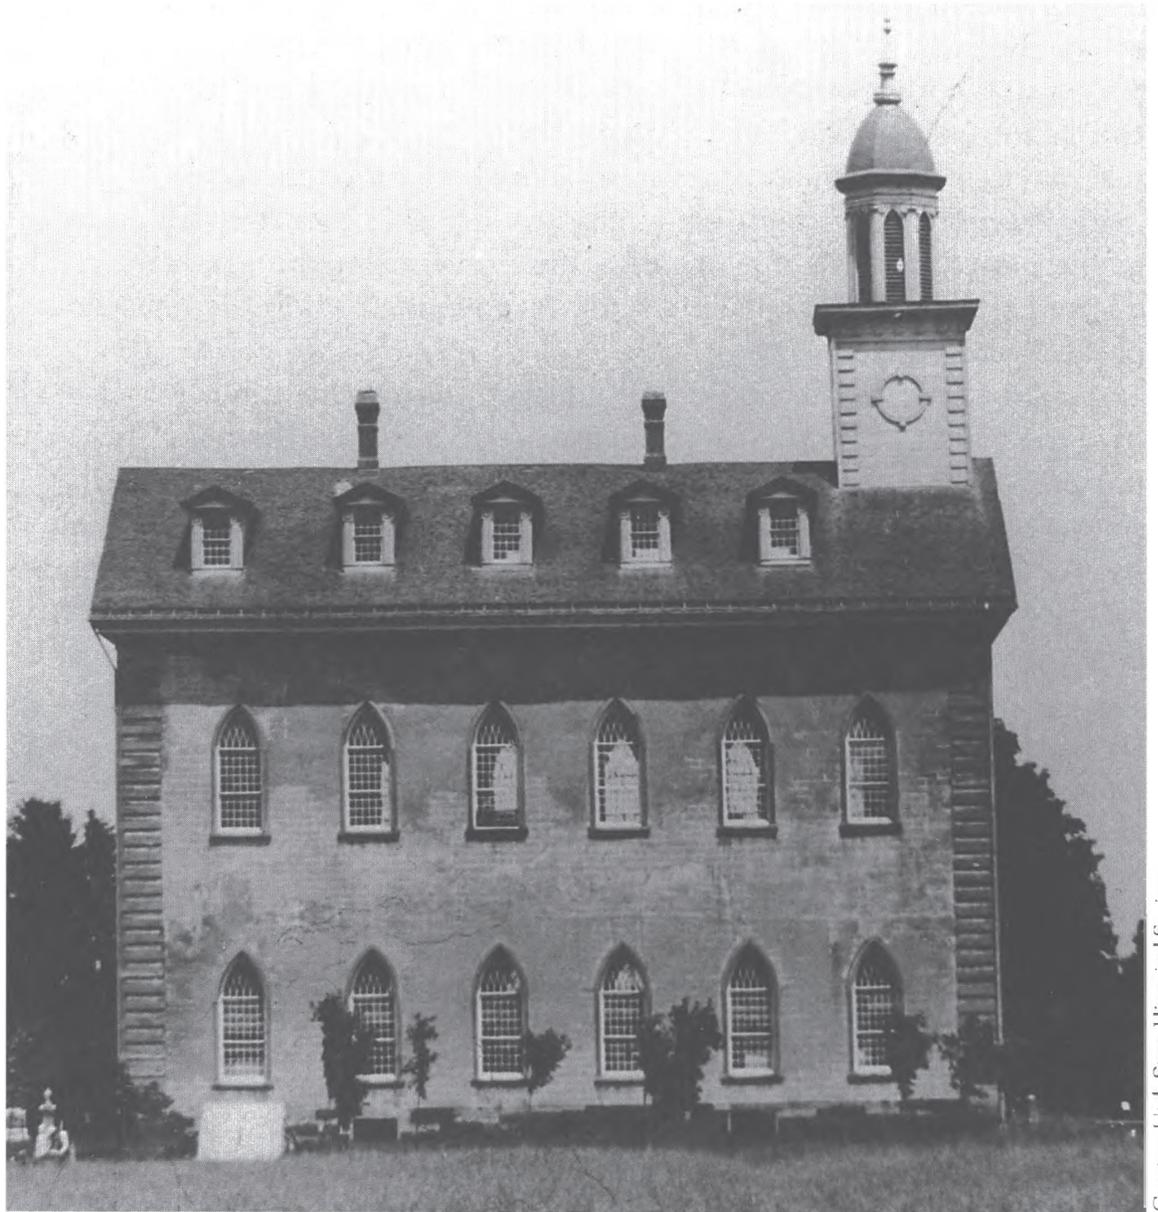
8-4. Kirtland Temple from the south, ca. 1902. By the time this scene was photographed, louvers had replaced the panels in the belfry arches (compare to fig. 8-3).

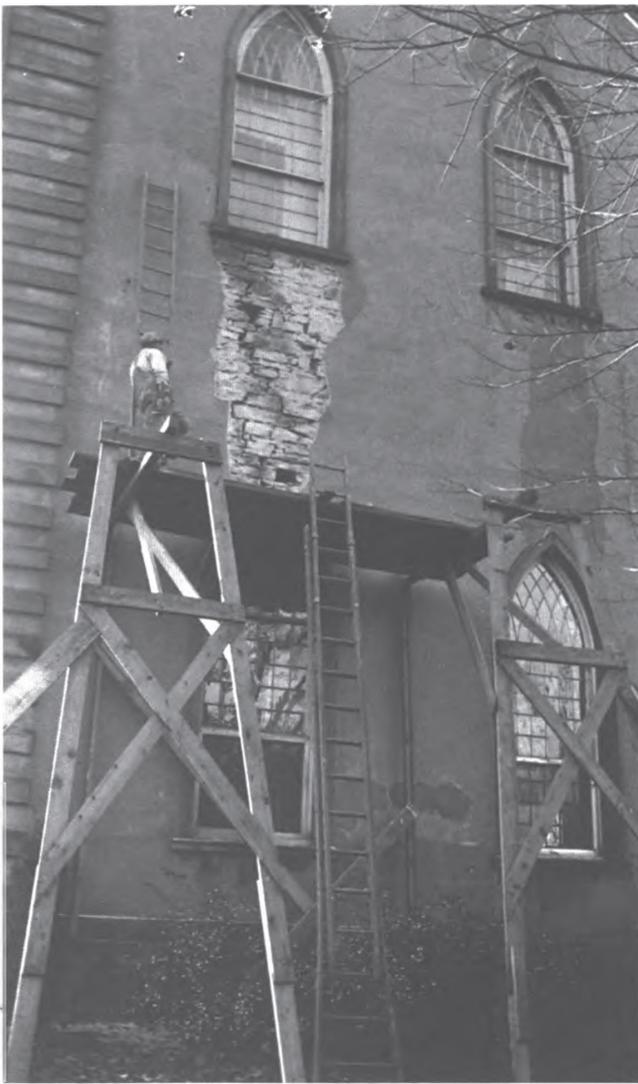
8-5. Repairs on the exterior stucco of the Kirtland Temple, northeast corner, unknown date. Vertical cracks between windows, still present today, allowed moisture to enter the wall and contributed to the deterioration of the exterior finish. The context of the photograph indicates that similar repairs were made to the other three elevations of the temple. Note the rubblestone construction and the two prominent “put-log” holes in the masonry where scaffolding timbers were inserted during construction. Note also that workers have painted joint lines on the repairs. These lines are visible in the photograph on the darker repairs and presumably match lines faded from exposure and not visible in the photograph on the lighter original stucco.

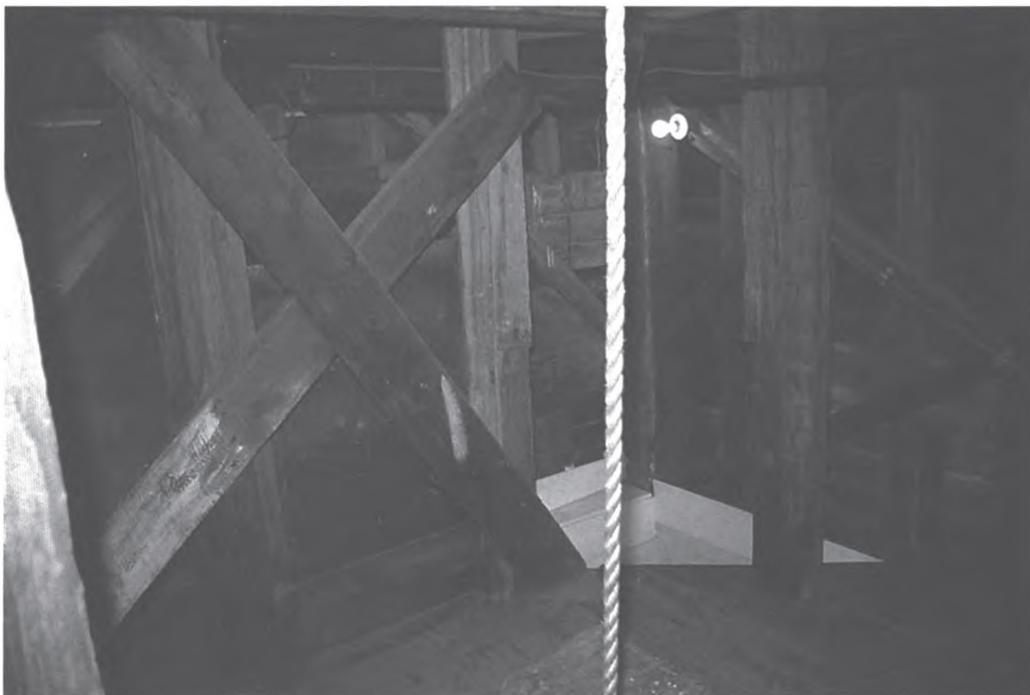
8-6. Interior of tower showing the repairs to the columns supporting the octagonal belfry above. New sections were spliced into the bottoms of the supporting columns and the interlocking beams were replaced.

The pattern of replacement timbers on the Kirtland Temple's belfry shows that water collected and ran down the eight timber columns that form the corners of the octagonal belfry (fig. 3-10). Where these columns rested on interlocking sets of four beams, the water pooled and was drawn up into the columns by capillary action in the wood cells. This saturation of the wood caused the bottoms of the columns and the four interlocking beams to decay. The repair consisted of splicing new sections on the bottoms of the supporting columns and replacing the interlocking beams that supported the belfry (fig. 8-6). These new timbers are differentiated from the 1830s timbers by the circular-saw marks visible on their surfaces. Graffiti on replacement timbers dates from 1904 and after, coinciding with documented repairs in that year.

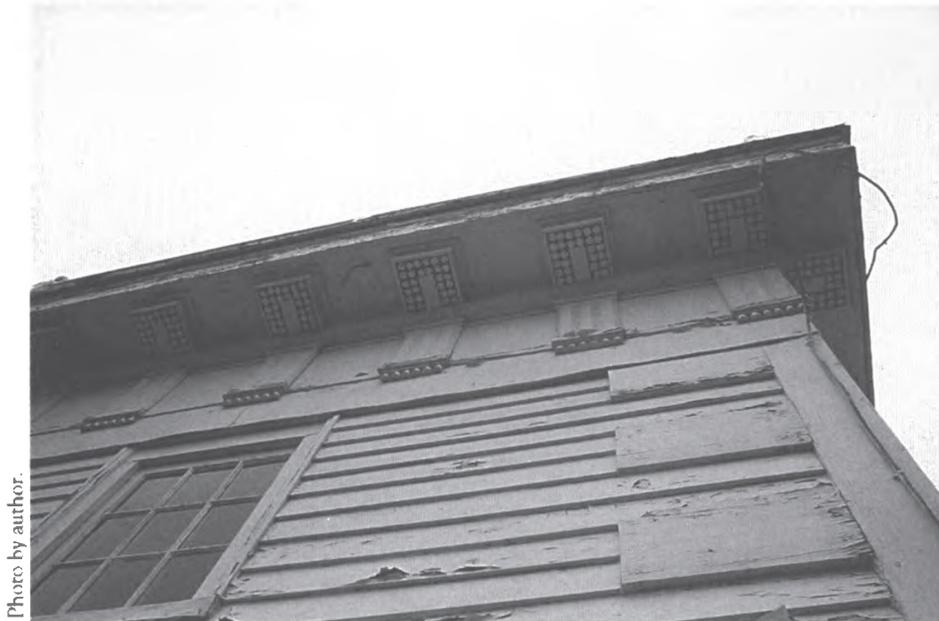
8-7. Detail of tower, Kirtland Temple, ca. 1992. Originally, the triglyphs of the Doric entablature would have been backed up by thick planking. The planking was replaced with thin composition board, which visibly bows over the window. Also note the overlapping clapboard, which replaced the original flushboard siding.

The rebuilt cornice of the tower also integrates old and new elements. This Doric cornice was composed of alternating triglyphs (blocks with three vertical "slots") and metopes (flat spaces between the blocks). The cornice was rebuilt using the original triglyphs, but the plank that originally composed the metope was replaced with a sheet of composition board similar to Masonite (fig. 8-7). Such a substitution for an original material does not meet current preservation standards but does reflect the 1950s American cultural worship of anything "new and improved."

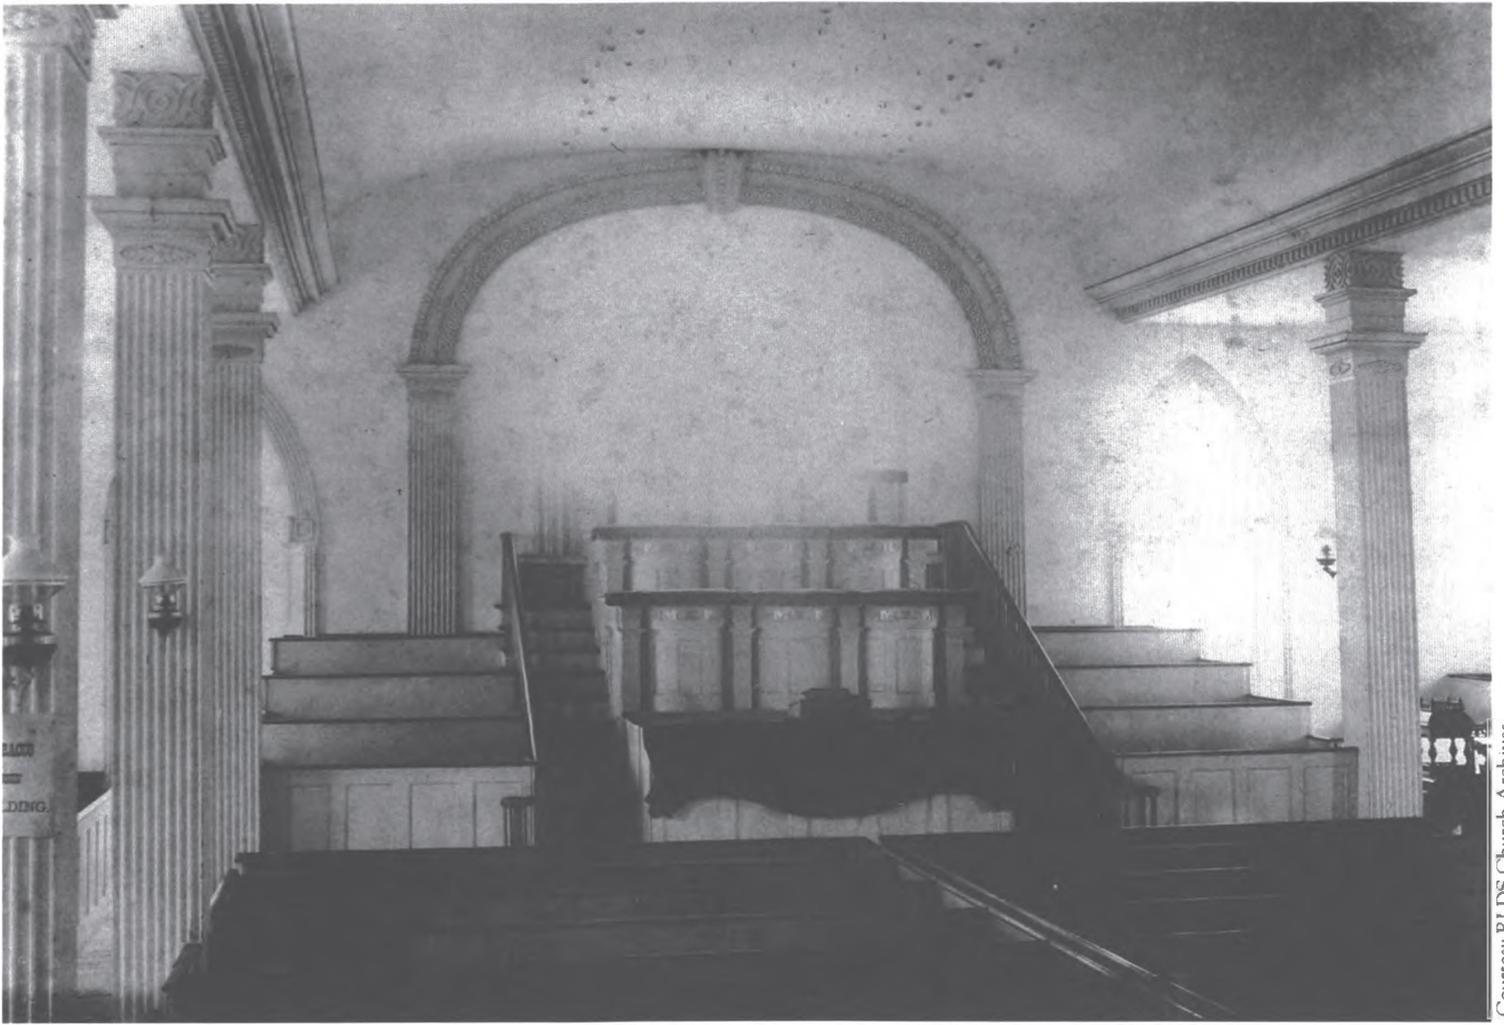
8-8. Lower court looking west, Kirtland Temple, ca. 1887, possibly photographed by James S. Ryder.

Figure 8-8 shows the west view of the lower court at nearly the same time as the previous photograph. This photograph shows the same stained wood finish inside the pew boxes, and the fabric pulpit covers and small benches are similar to those seen on the east. A small organ is visible to the right, and a glimpse of the aisle shows the wood floors typical of the period.

Figure 6-1, dated 1912, shows several small changes that occurred in the years following the previous view. The gas lamps installed in 1899 have already been modified for electricity.²⁸ A darker color of paint accents the window mullions. The small cracks visible in figure 8-8 between the west wall and the vault have now grown very large and unsightly. It was probably during these years that the west wall shifted outward just over an inch due to the foundation settlement discussed in chapter 3. (Later in the 1950s, tie rods, seen in figure 8-9, were run from wall to wall between the floors to prevent the cracked walls from shifting further.) The water damage visible between the keystones also shows that the cracking on the exterior was

extensive enough to allow water to seep through the wall and damage the interior plaster. Here, the westernmost (front) pew has been removed, leaving only two pews to the west of the second column instead of the three visible in figure 8-8. This alteration was made to allow passage when the sacrament table was swung up for use during Sunday worship services. Finally, the most visible element in the photograph is the large curtain suspended by ropes from the ceiling. As was discussed in chapter 6, the curtain hangs in an unsightly fashion, destroying the architectural effect of the elliptical vault.

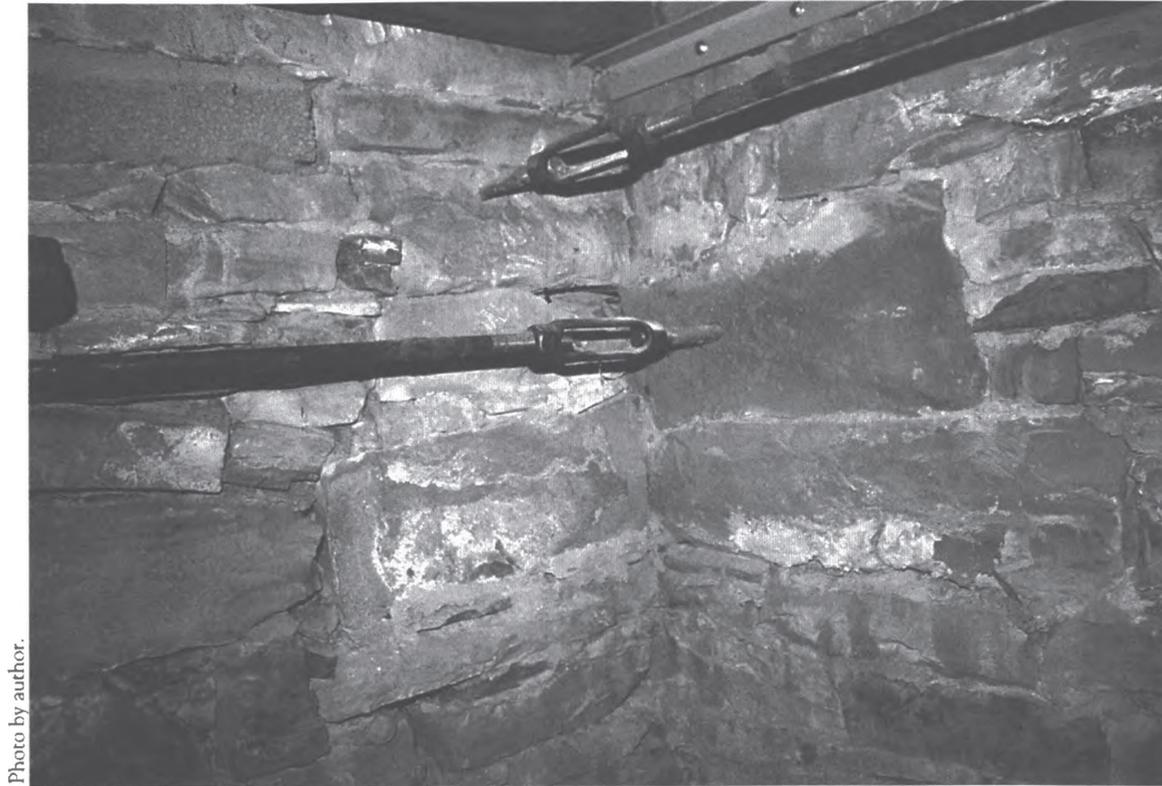
8-9. Southwest corner between the lower court ceiling and upper court floor, Kirtland Temple. The tie rods were installed during the 1950s to restrain the outward movement of the walls.

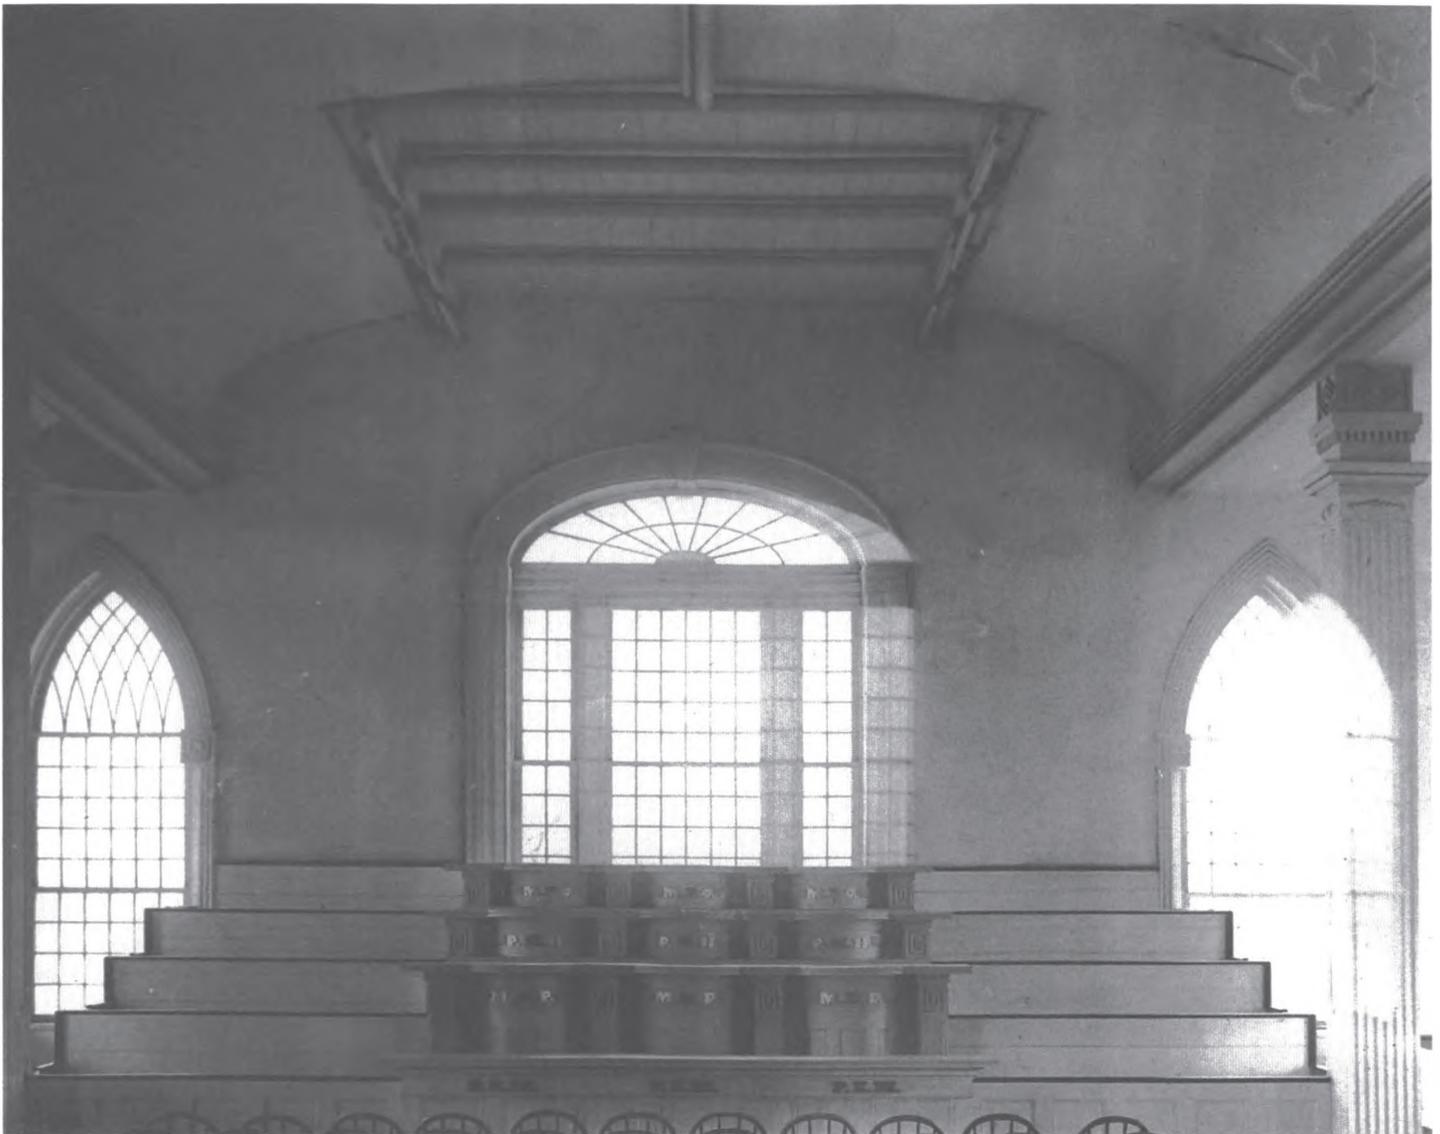
8-10. Upper court looking west, photograph by George Edward Anderson, August 1907. Cracking at the junction between the ceiling and the west wall mirrors that shown in Fig. 6-1 although the cracking is not as extensive. Also note the missing plaster in the ceiling to the left. Chairs were used in the upper court before pew boxes imitating those in the lower court were installed sometime between 1918 and 1931.
